CITY LAKE DAM

CASS COUNTY, MISSOURI

PHASE 1 INSPECTION REPORT NATIONAL DAM SAFETY INSPECTION

Name of Dam	City Lake Dam
State Located	Missouri
County Located	Cass County
Stream	Town Creek
Date of Inspection	12 April 1979

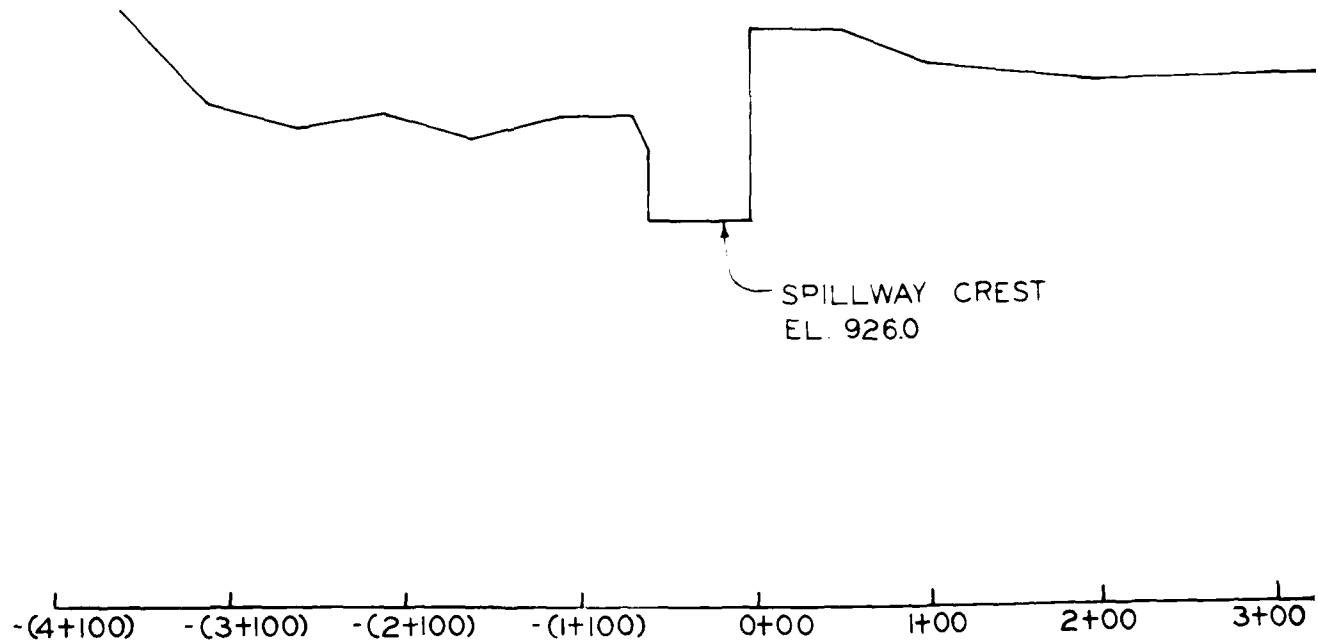
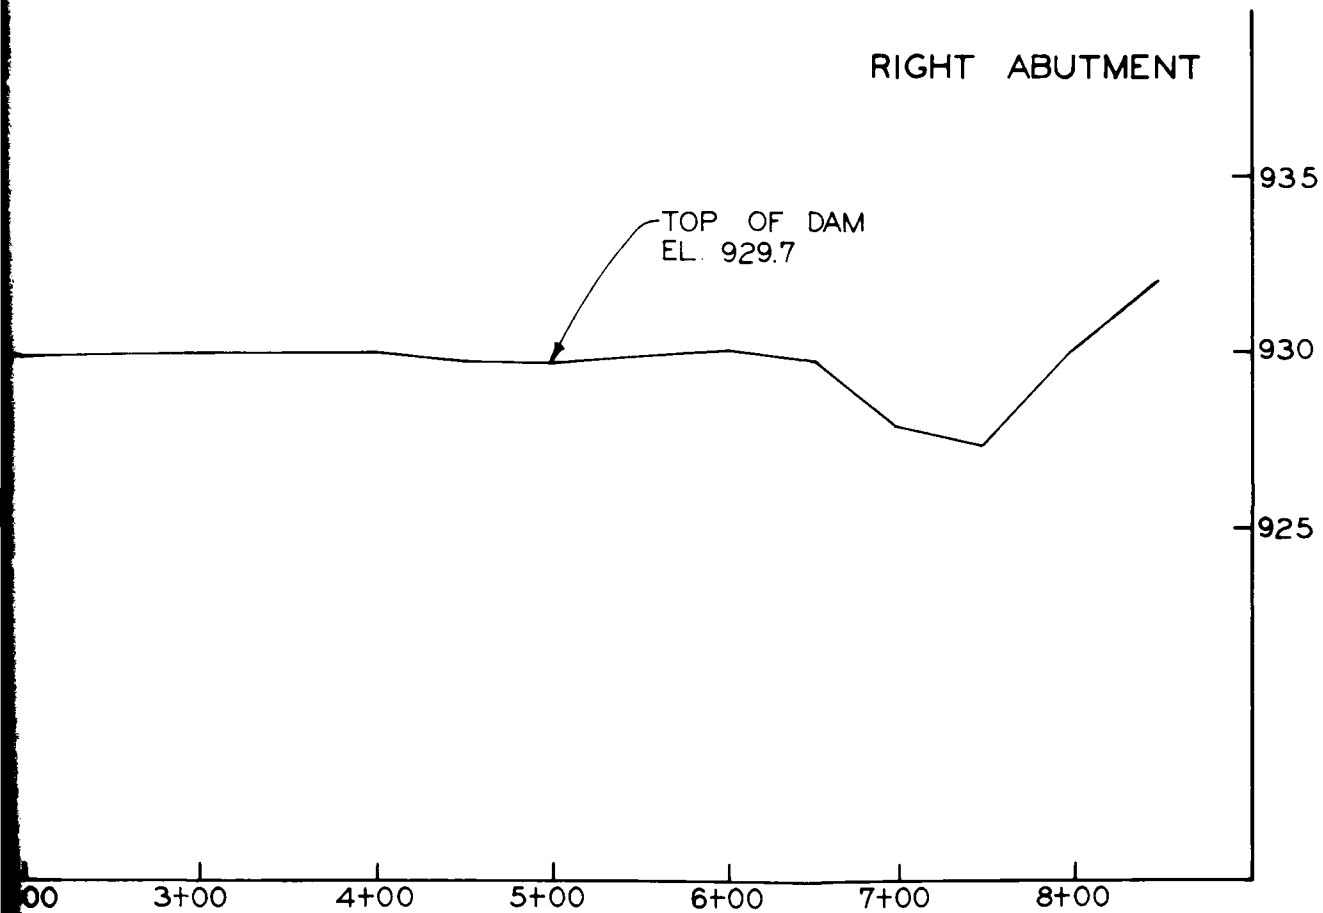
PLATE 4

(3) The abutments at each end of the dam are lower than the dam itself. These low sections will act as emergency spillways in conditions of high inflows (see Plate 4).

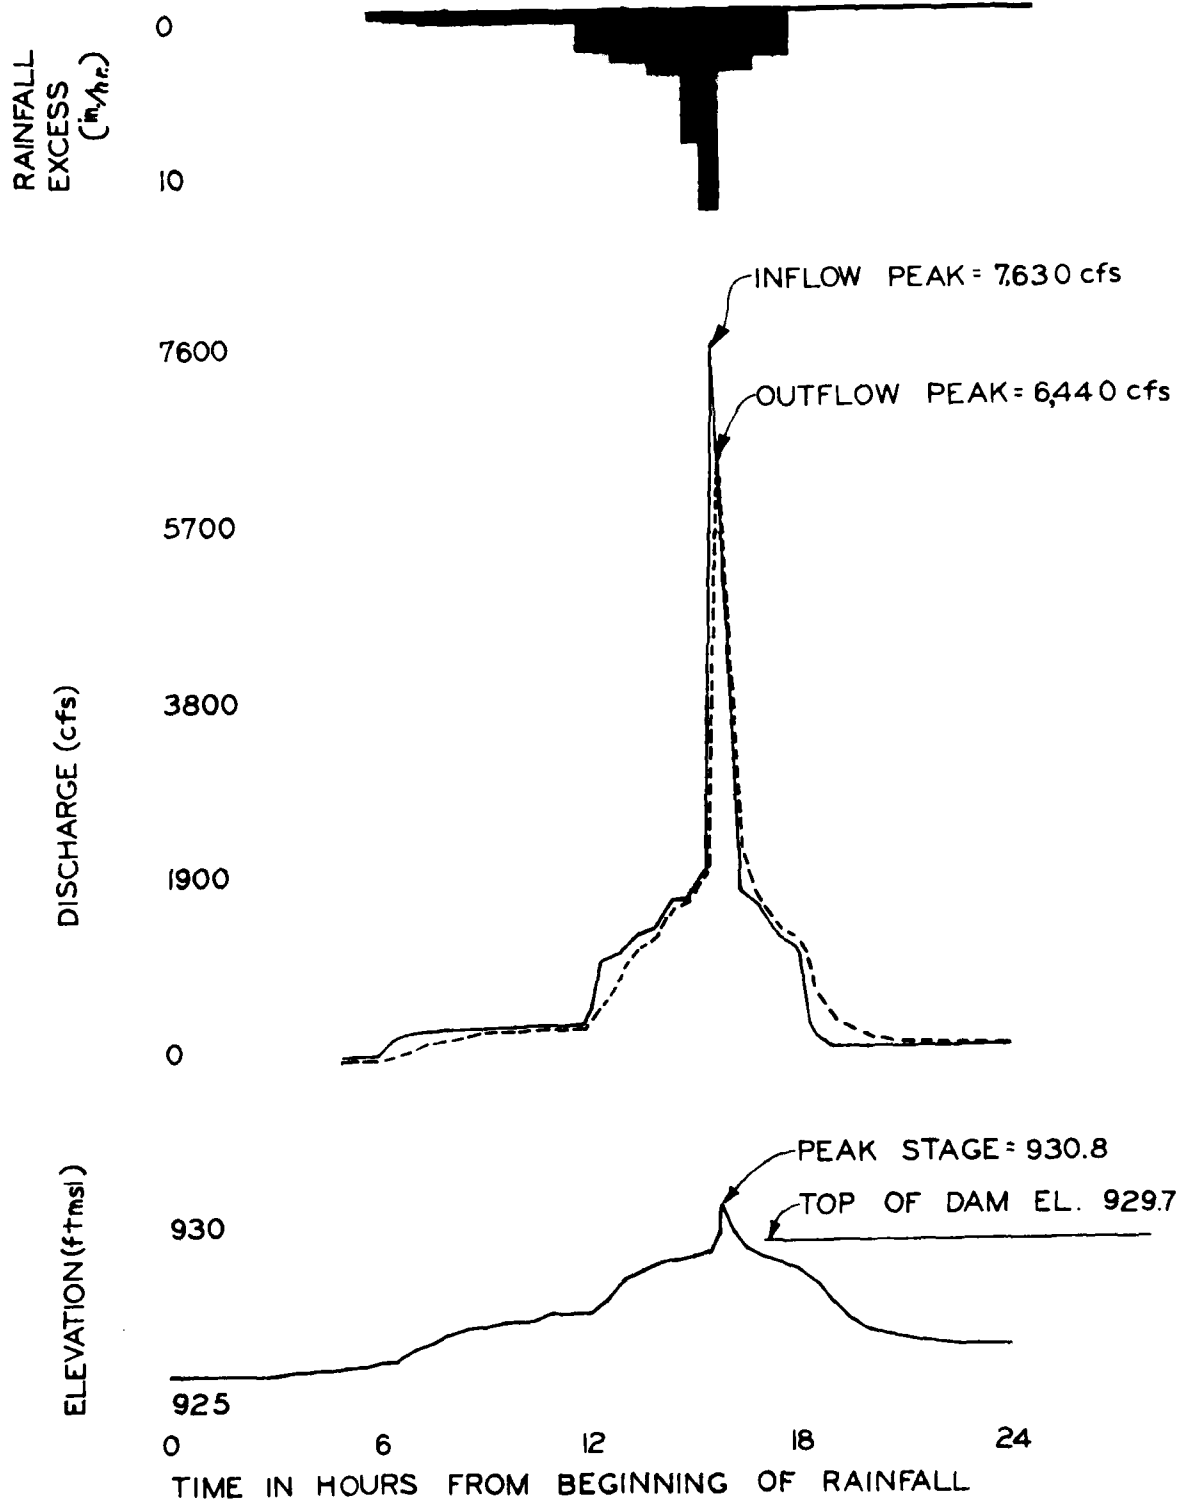
PLATE A-1

4. Floods are routed through the spillway using HEC-1, modified Puls to determine the capability of the spillway. Inflow and outflow hydrographs are shown on Plates A-1, A-2, and A-3.

**CITY LAKE DAM
PROBABLE MAXIMUM FLOOD
HYETOGRAPH, HYDROGRAPH AND
STAGE-TIME CURVE**

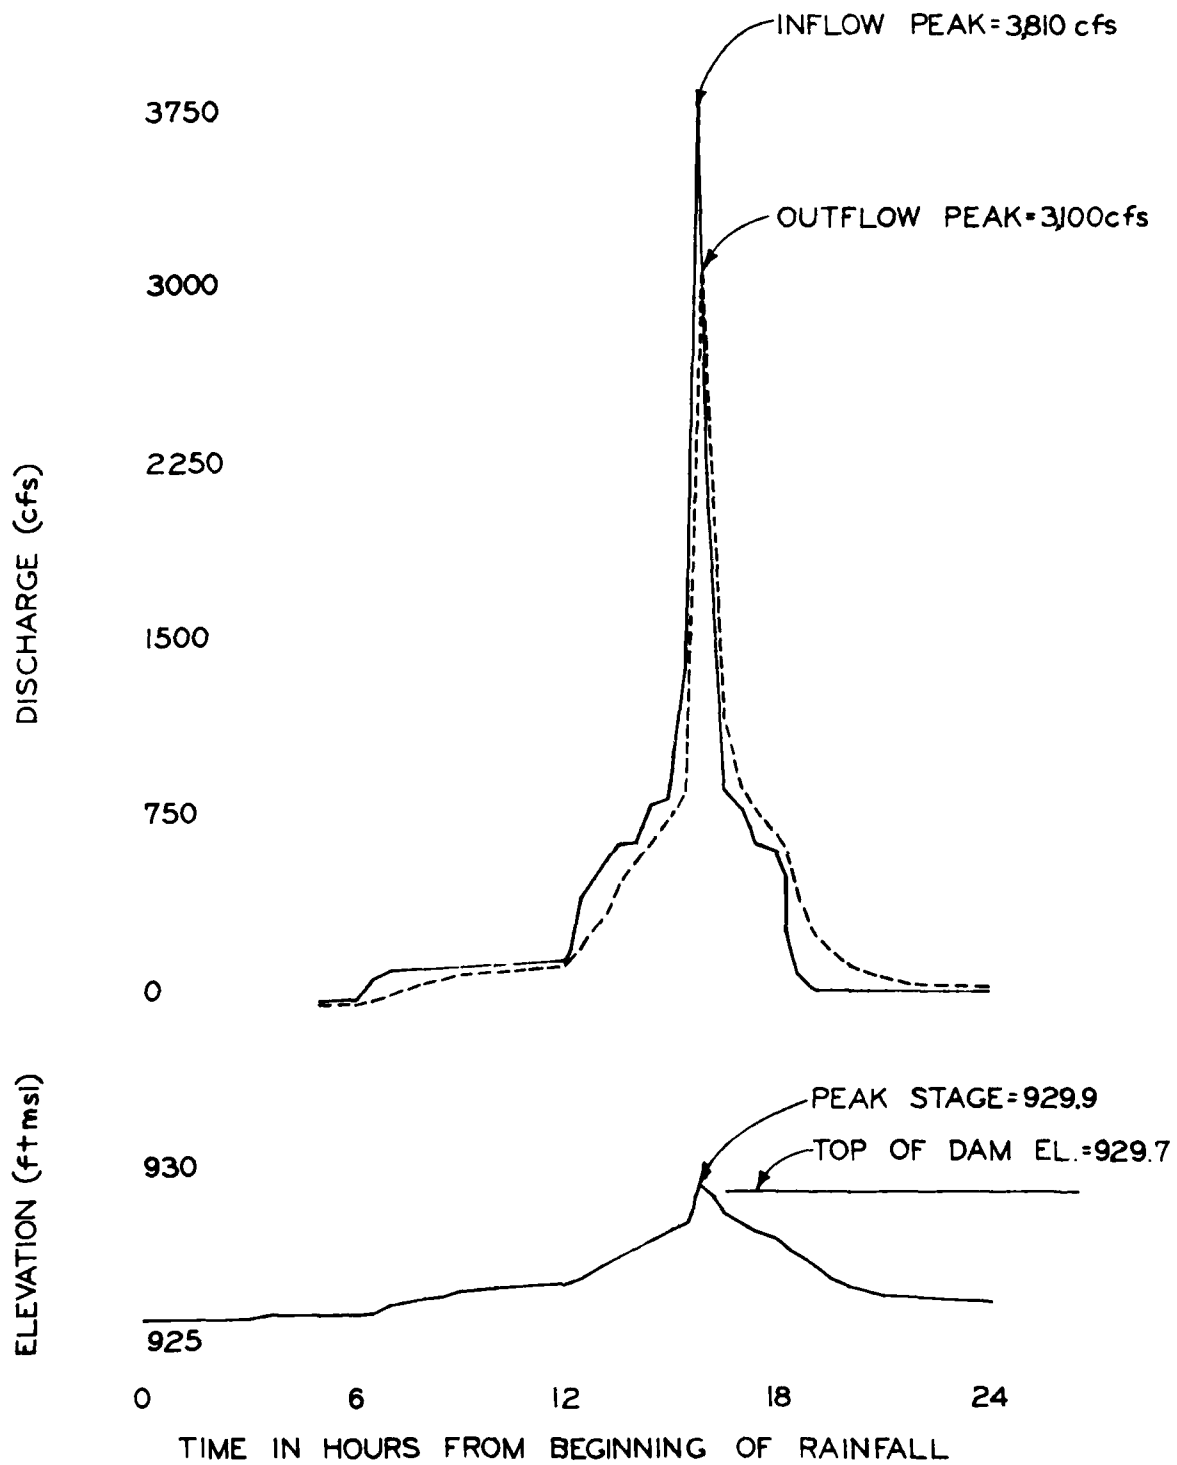
CITY LAKE DAM
50% PROBABLE MAXIMUM FLOOD
HYDROGRAPHS AND
STAGE-TIME CURVE

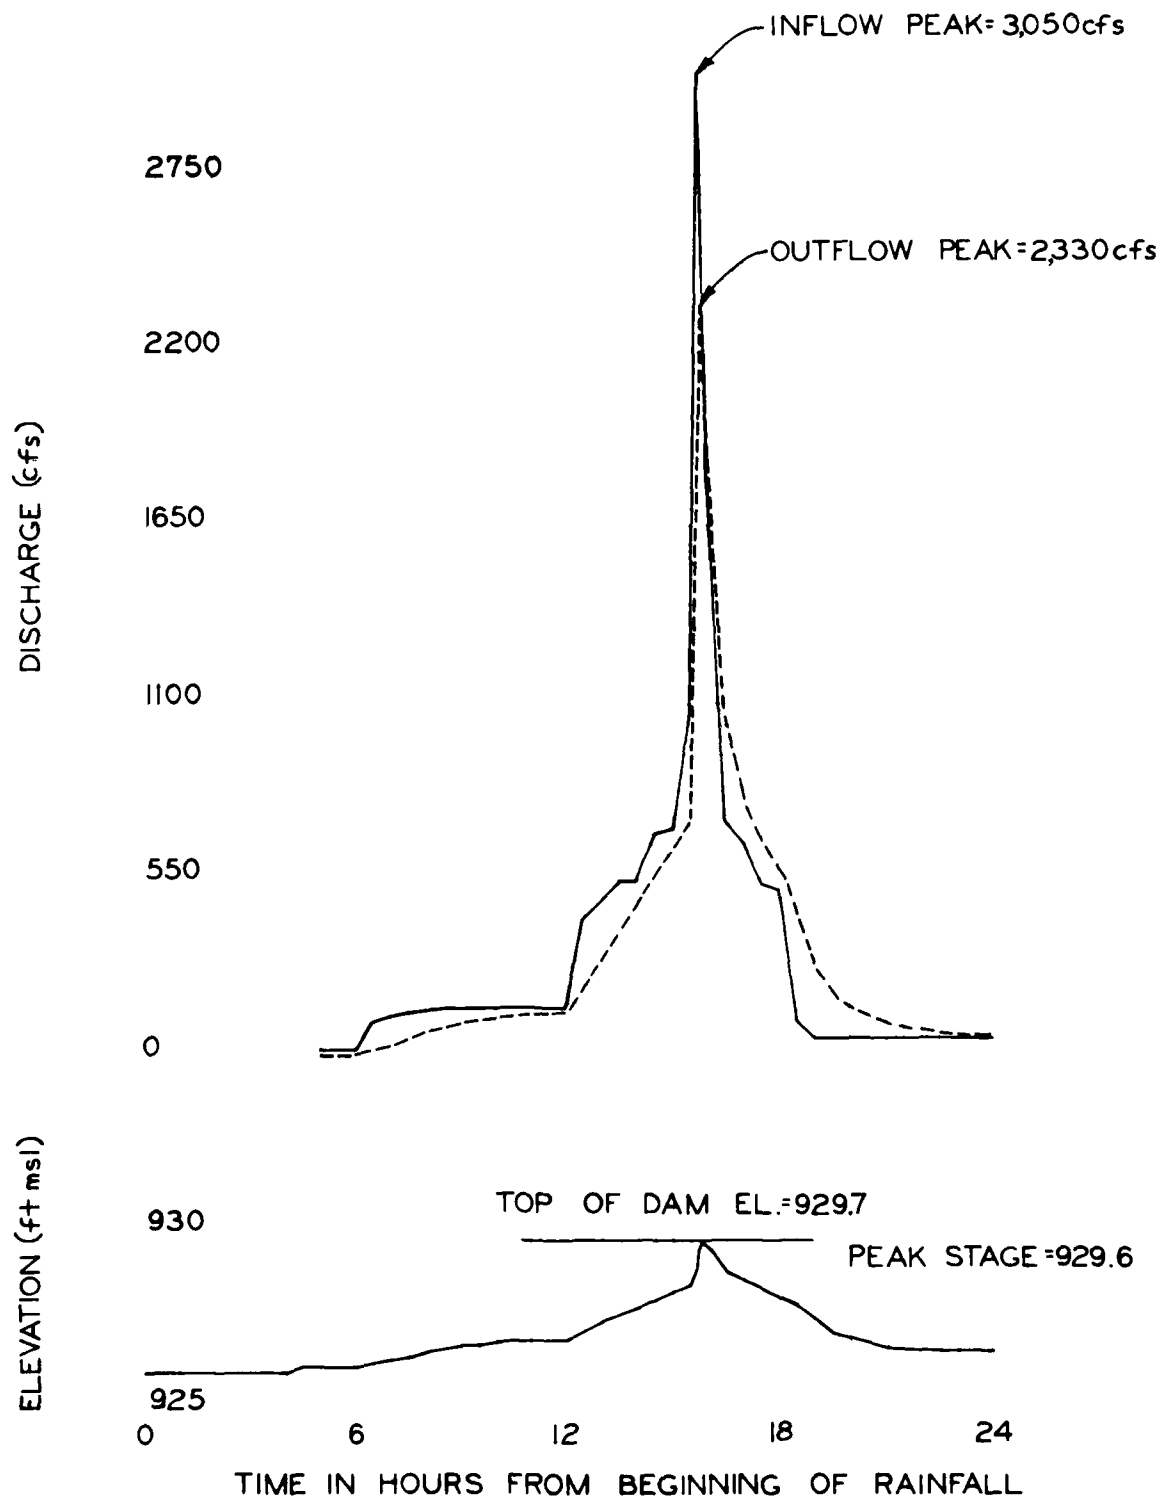
CITY LAKE DAM
40% PROBABLE MAXIMUM FLOOD
HYDROGRAPHS AND
STAGE-TIME CURVES
